**FINAL REPORT**

**Demonstration of ECDA Applicability and  
Reliability for Demanding Situations**

**DOT Prj#195**

Gas Technology Institute

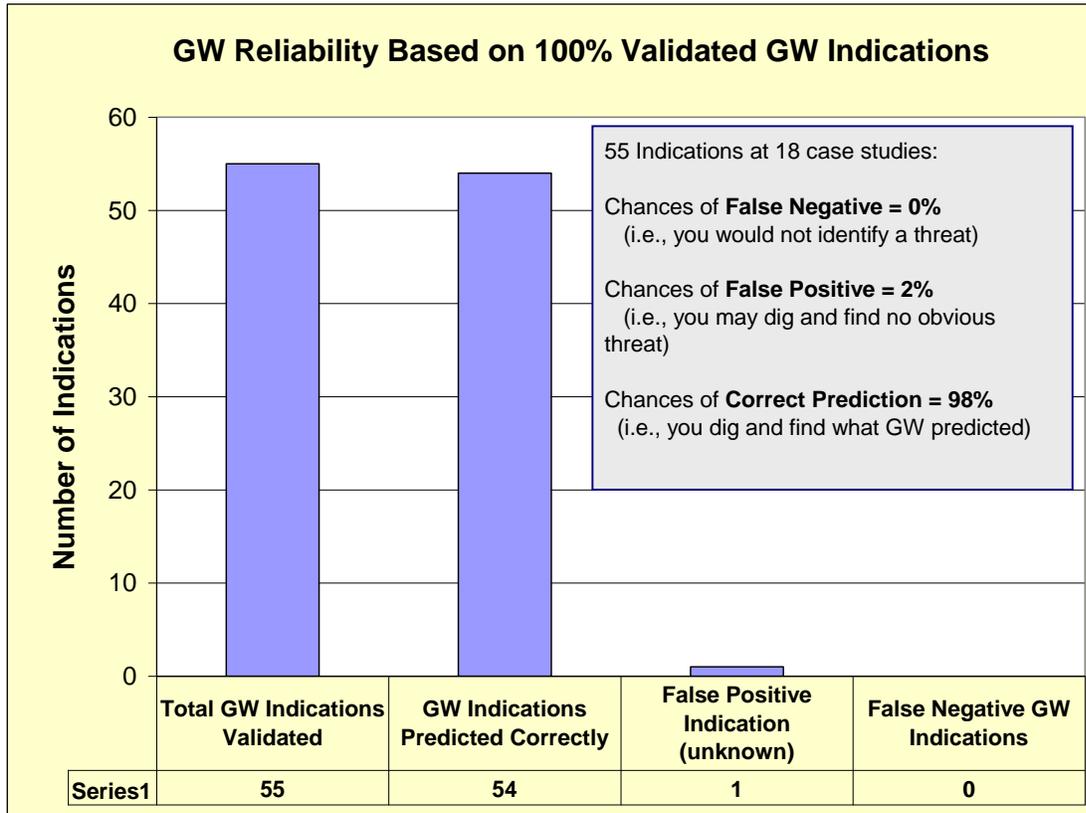
Figure 1. Guided Wave reliability based on 100% validated GW indications (18 case studies - 55 indications; all pipe was uncovered; coating was removed to get to bare metal; further inspection beyond visual was done as necessary, e.g. X-Ray, PortaScan UT, etc.). Note: the lack of any false negatives *includes* all the length of pipe inspected and is a very encouraging result in itself.

GWUT produced very good reliability numbers even though the cases all had very small corrosion damage or none at all. When the casing and coatings were removed, the GWUT operator successfully called all the predictions.

No corrosion was found that was not predicted, however one location had corrosion less severe than the prediction, confirming that the tool signals (when interpreted by the current service providers) are basically conservative.

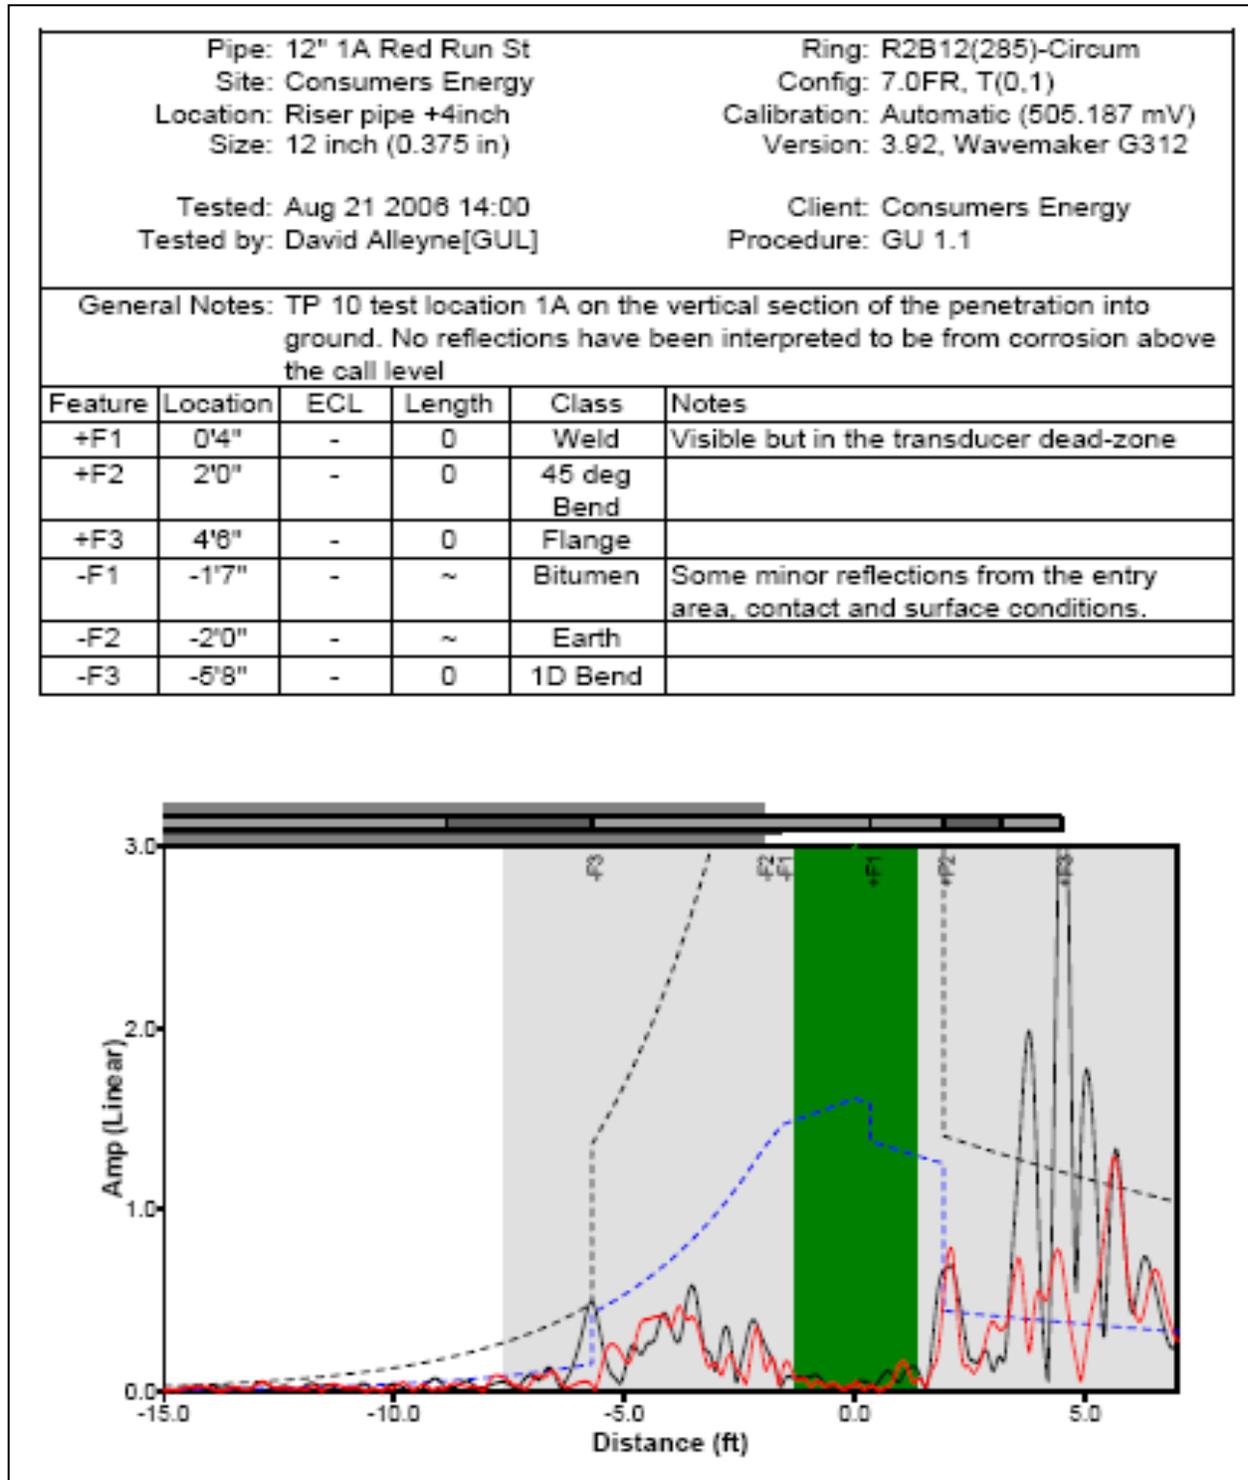
Dig Site 1A - PE

Figure 9. Dig Site 1A - PE.

All GW scans/reflections suggest no significant corrosion or wall loss (medium confidence).

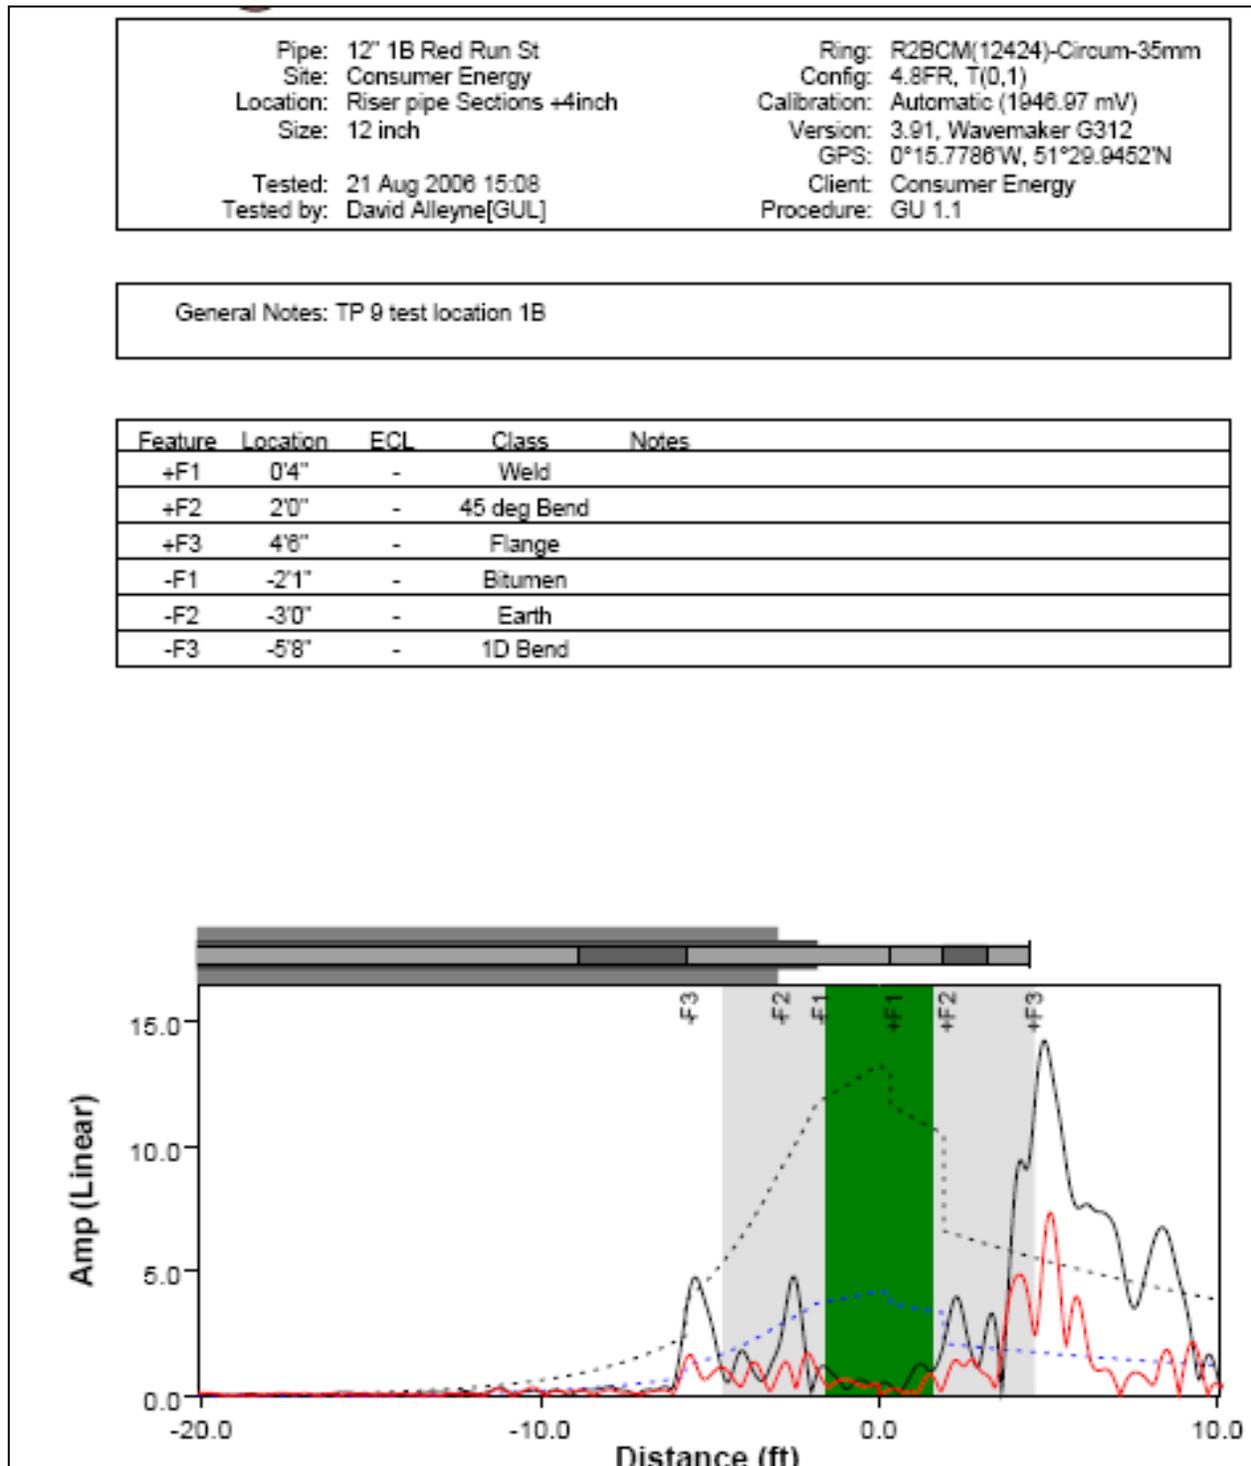
Dig Site 1B - PE

Figure 10. Dig Site 1B - PE.

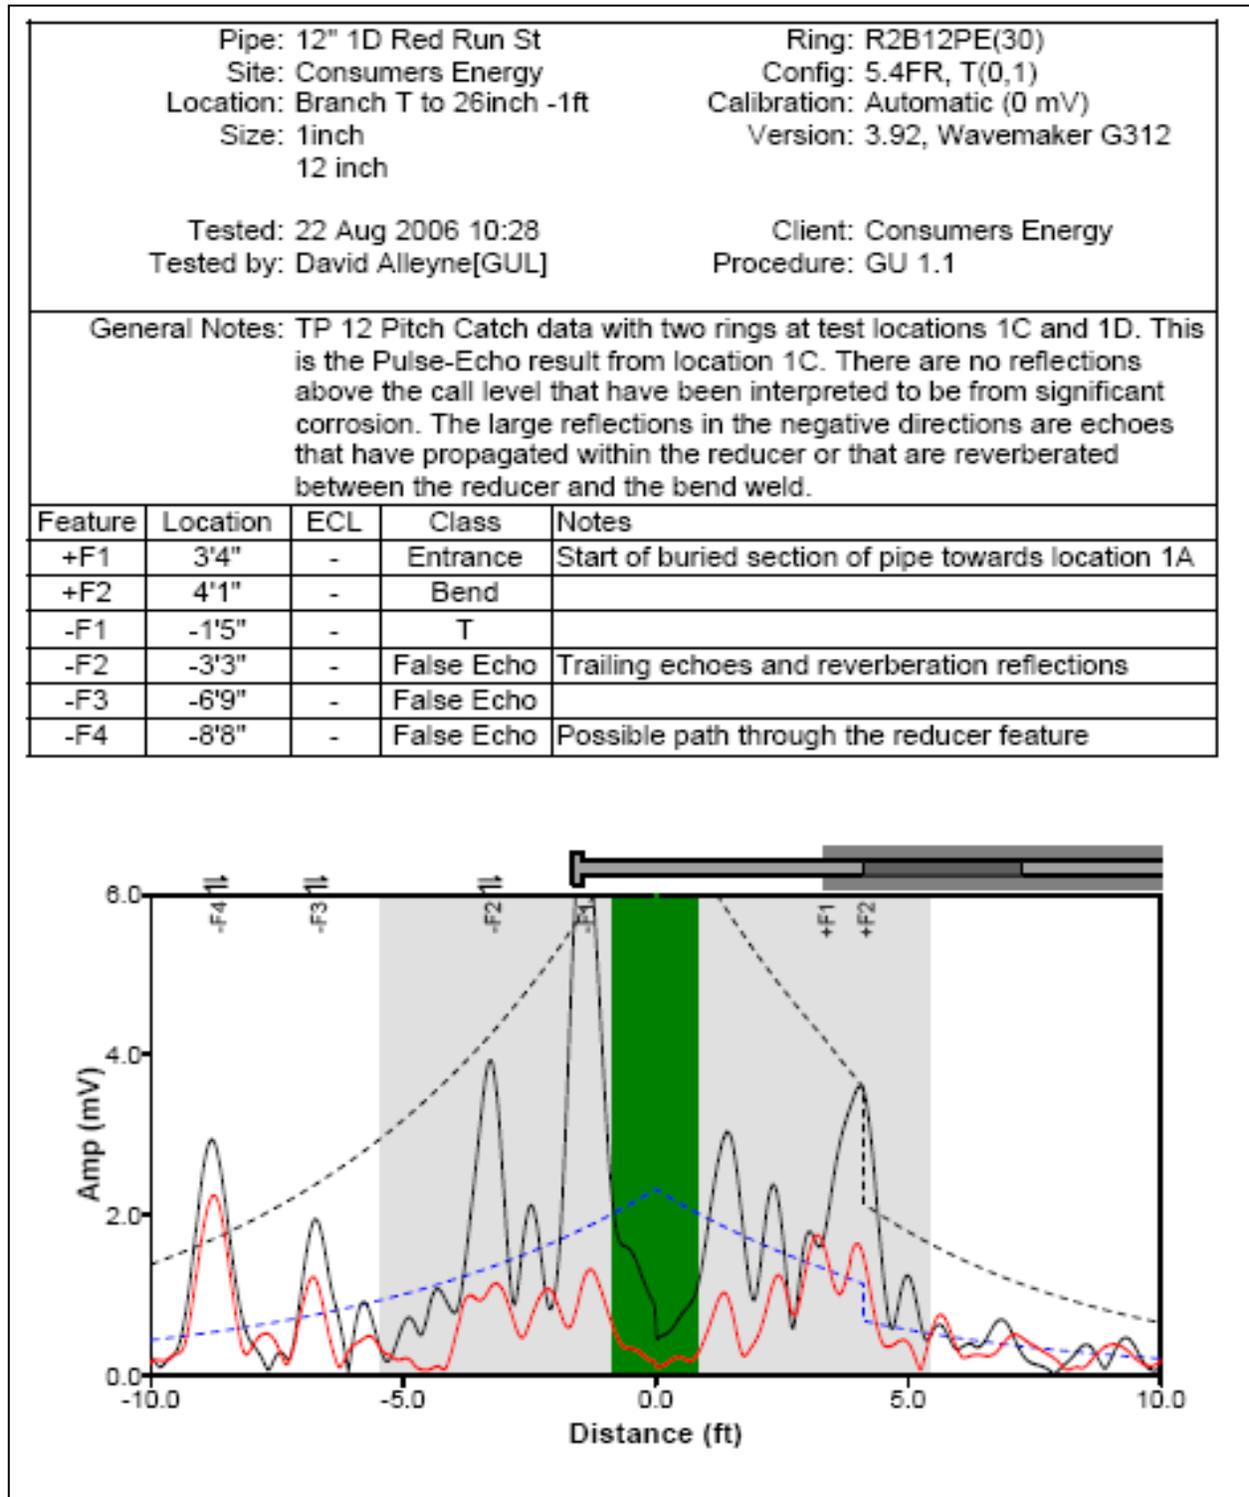
Dig Site 1C - PE

Figure 11. Dig Site 1C - PE.

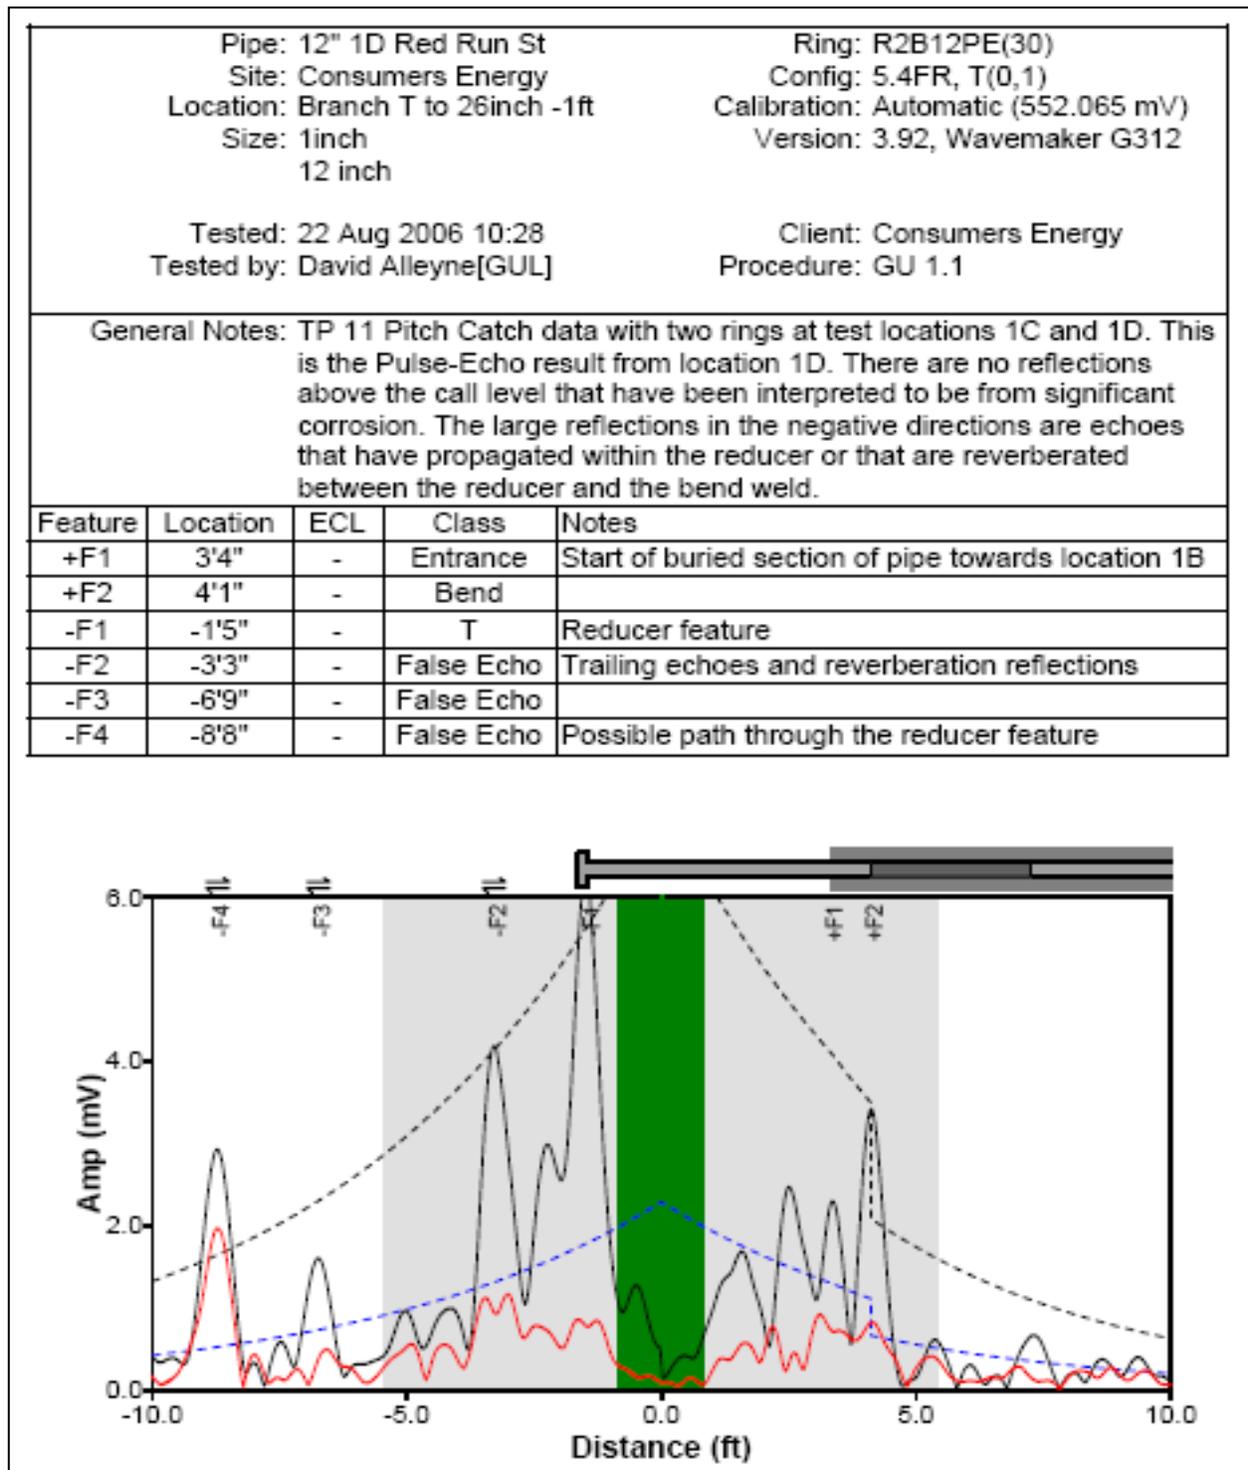
Dig Site 1D - PE

Figure 12. Dig Site 1D - PE.

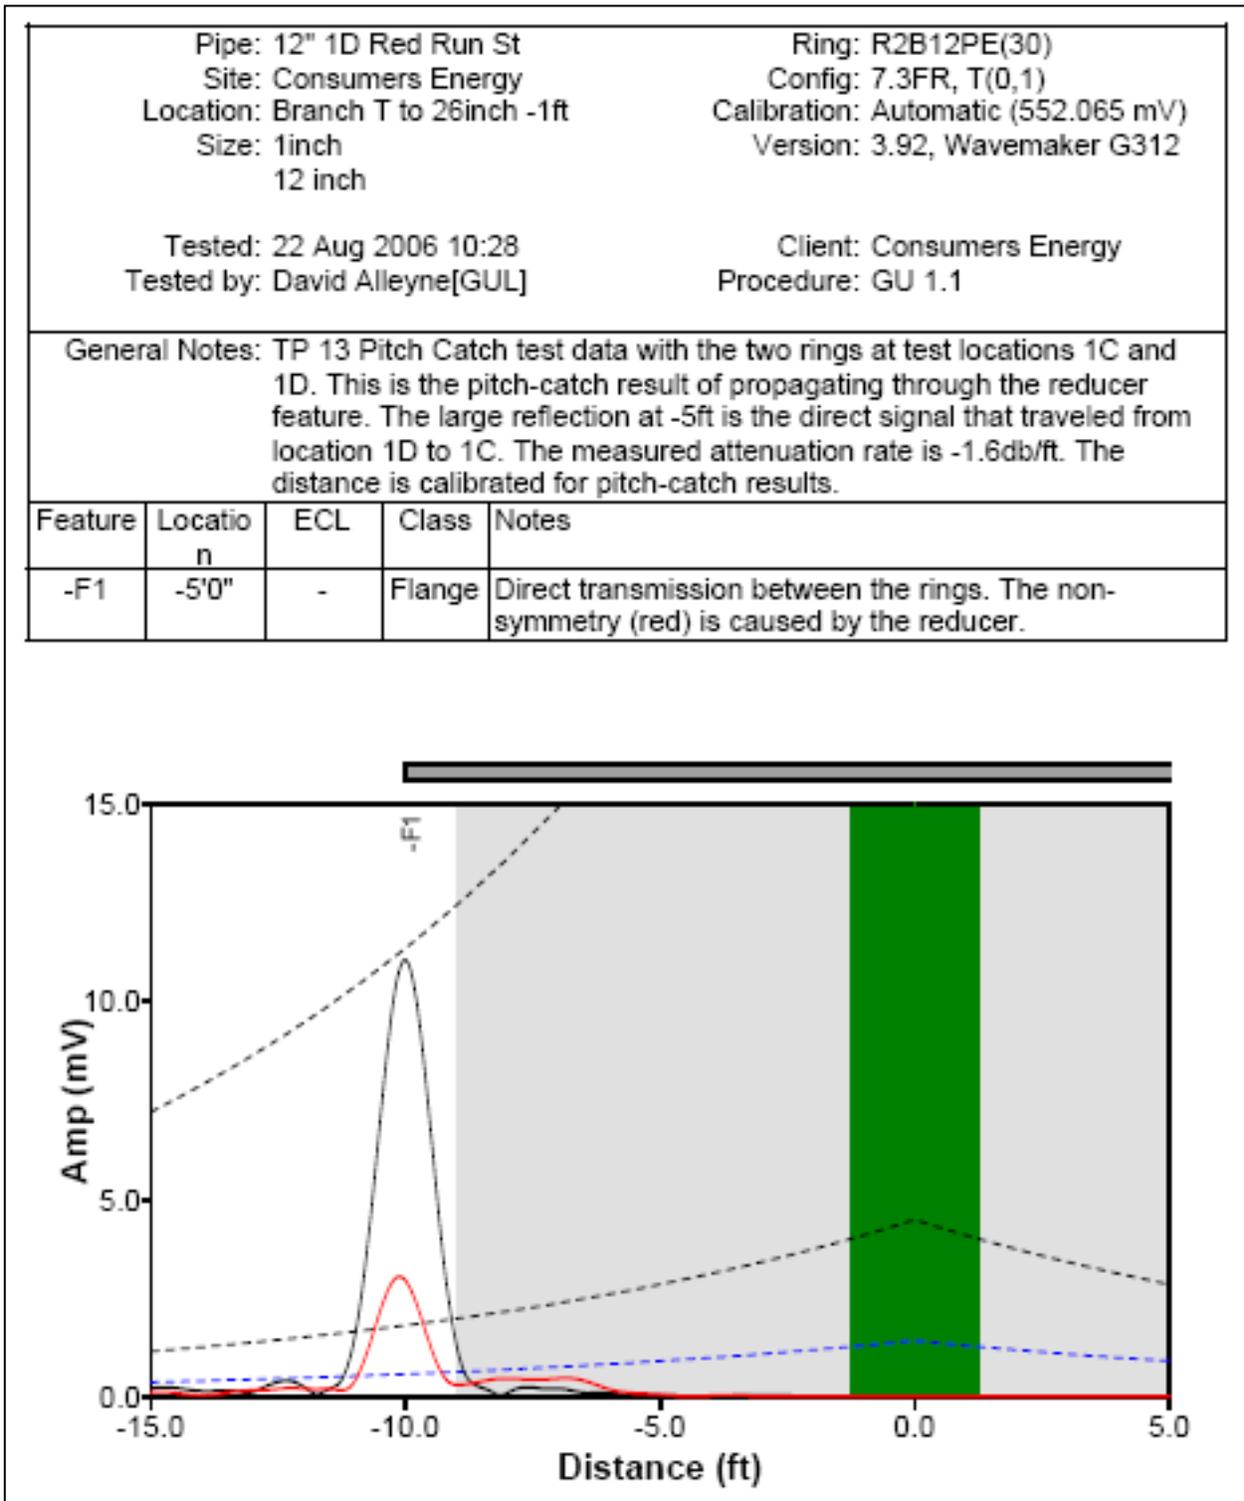
Figure 13. Dig Site 1D - PC.

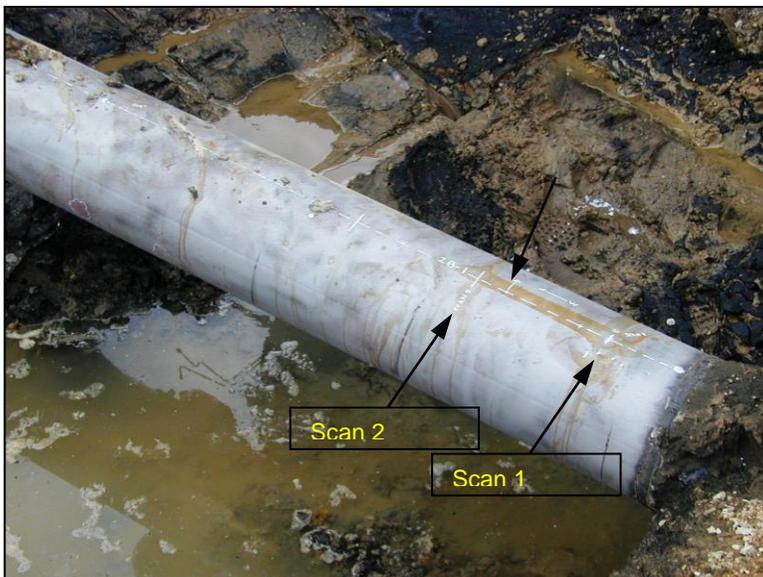
**Figure 22. Scan 2 and Scan 1 locations.**

No density changes consistent with the presence of localized corrosion were visible. Light density of the film with minor changes was visible and is believed to have been caused by material buildup in the pipe.

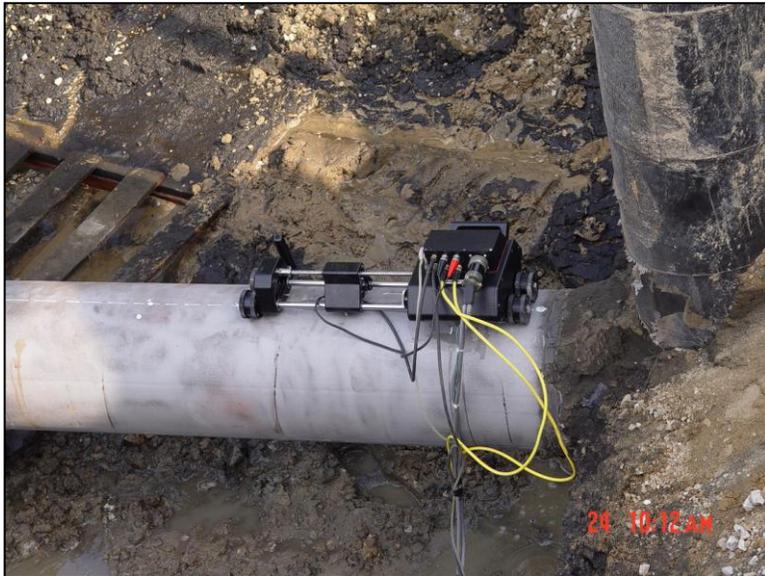
**Figure 23. Porta-Scan UT in operation.**

Ultrasonic Inspection consisting of two scans were performed. Each scan measured 1 foot longitudinally at the 5:00 to 7:00 positions on the pipe. The green arrow shows the 12:00 Lo position on the pipe. Yellow arrows show the starting positions of Scans 1 and 2.

Ultrasonic Inspection consisting of two scans were performed. Average wall readings for both scans measured 0.369" and the minimum reading for both scans measured 0.329" at Lo+12.5", 6:30 position.

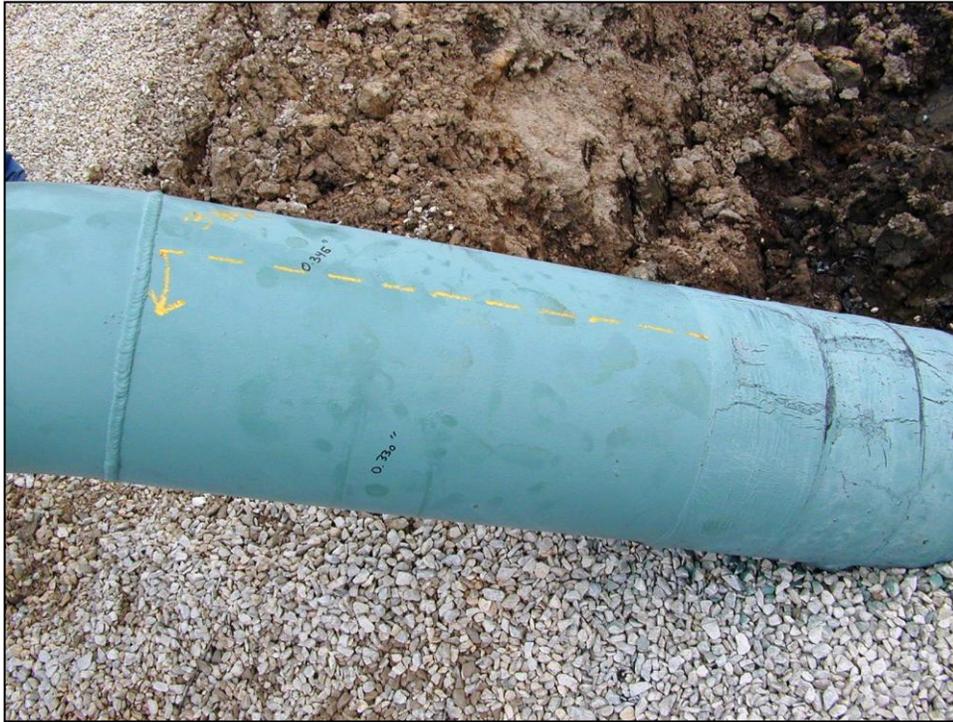
**Figure 35. Area 3B (South Meter Run Riser).**

A single RT image at the 06:00 position was produced. The Lo position is shown marked on the pipe with the CW arrow direction. No density changes consistent with the presence of localized corrosion were visible. View is looking to the north.

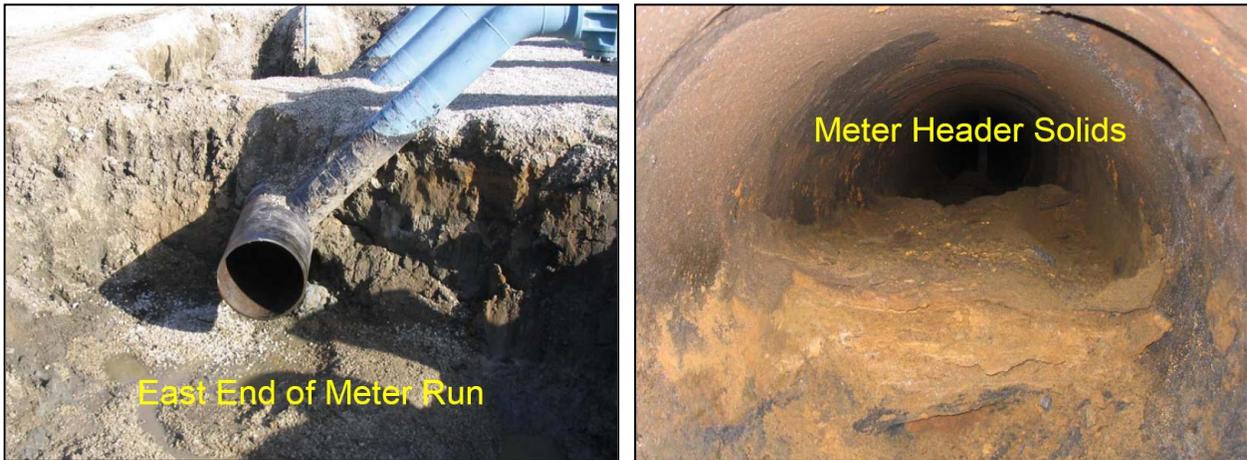
**Figure 36. East end of meter run and meter header solids.**

Stub and riser at the South end of the inlet to the meter run – Inspection by the GUL unit indicated the piping to be significantly blocked.

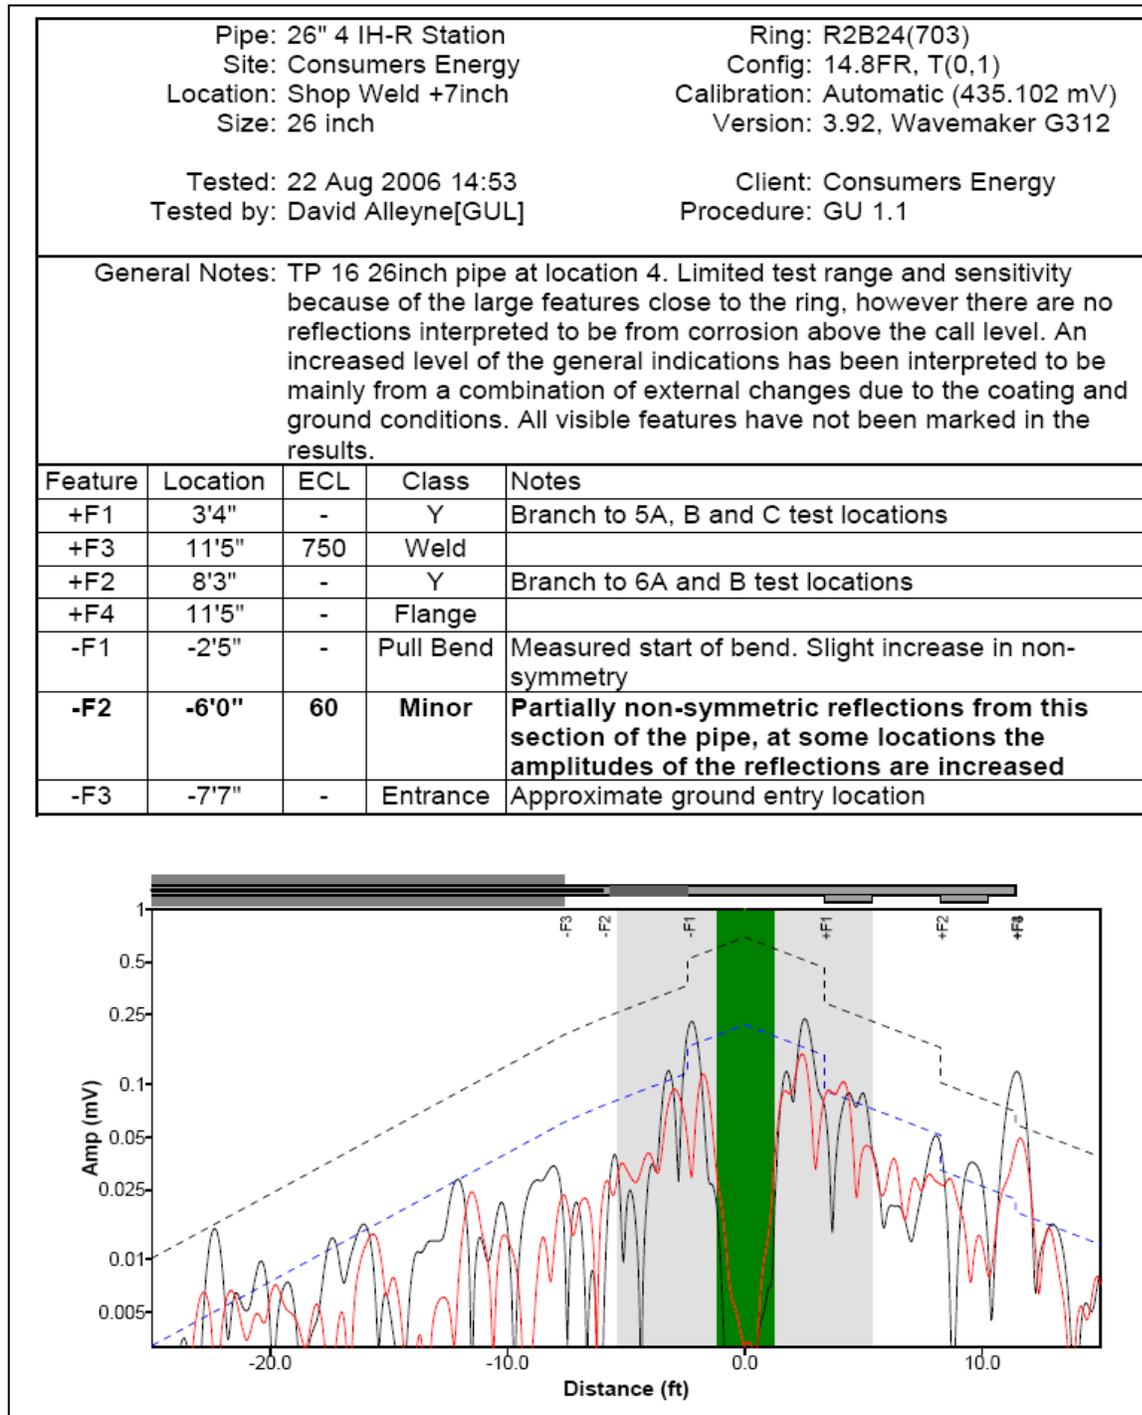
Figure 38. Dig Site 4 - PE.

Reflections at dig site 4 - Limited test range and sensitivity because of the large features close to the ring, however there are no reflections interpreted to be from corrosion above the call level. An increased level of the general indications has been interpreted to be mainly from a combination of external changes due to the coating and ground conditions. Category 3 Call with Medium Confidence.

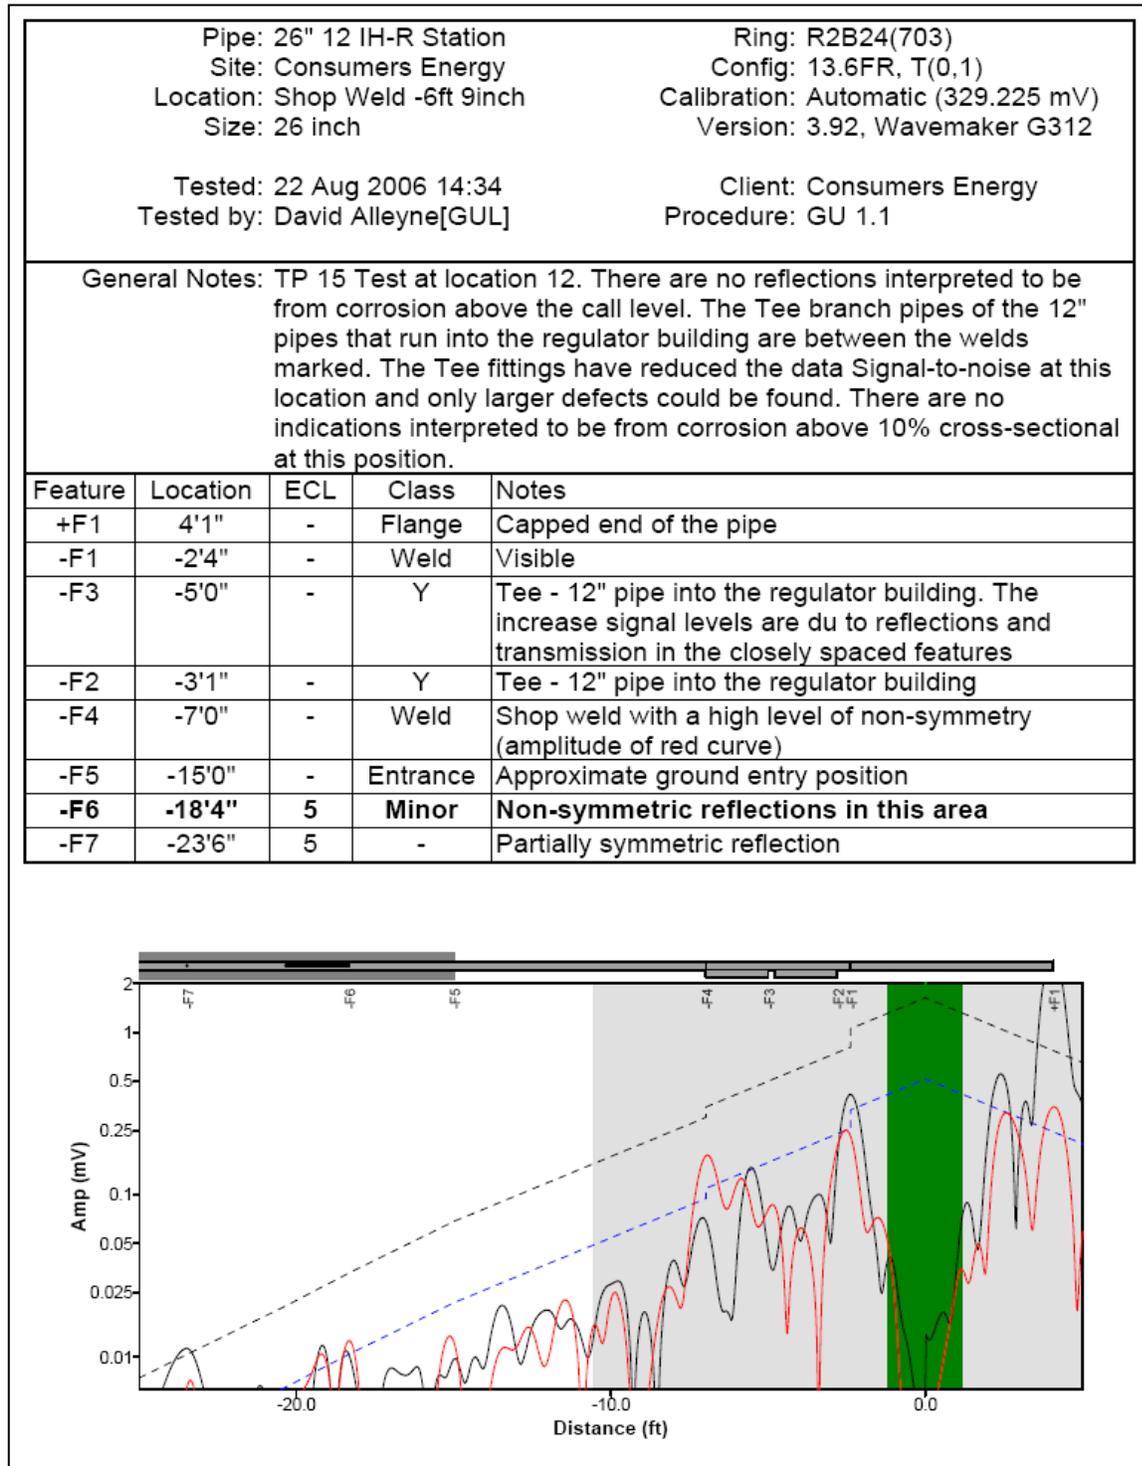
Figure 39. Dig Site 12 - PE.

Reflections at dig site 12 - There are no reflections interpreted to be from corrosion above the call level but the Tee fittings have reduced the data Signal-to-noise at this location. Category 3 Call with Medium Confidence.

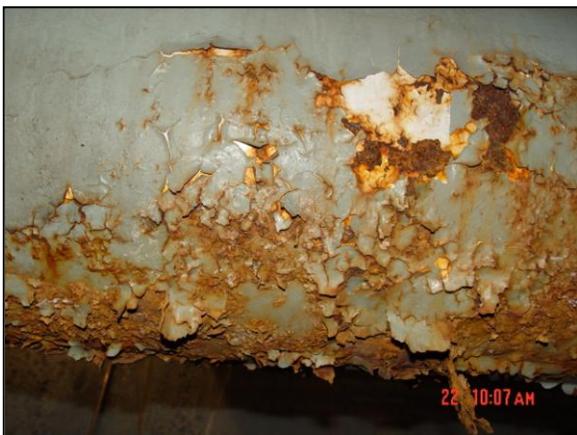
Figure 43. Site 5C.

Distribution outlets (5C and 6B) in the basement of the Regulation Bldg had some significant corrosion adjacent to the wall which is cased with a link seal insulator.

- Pitting was observed at the 6:00 position (bottom of pipe). Guided Wave testing with the GUL G-3 picked up this anomalous condition, though exact pitting depths could not be determined.
- Visual inspection indicated general corrosion with an isolated 1.5 in. long area of pitting (0.100" to 0.130") extended to within approx. 3 inches of the wall. The corrosion is atmospheric in nature and possibly occurred from wet-dry cycling of the outlet piping in conjunction with poor coating. The piping is 12 inch, grade B, 0.375" wall.

- ASME B-31-G mod. was performed and indicted the piping safe to remain in place. This area is adjacent to the wall and has a casing with link seal thru the penetration.
- Data obtained from defect assessment on the basement side as discussed in the previous bullets was used to provide calibration of GUL unit allowing evaluation of waveforms within the casing. Corrosion in the casing was no more severe than that found in the basement and piping was safe to remain in place.

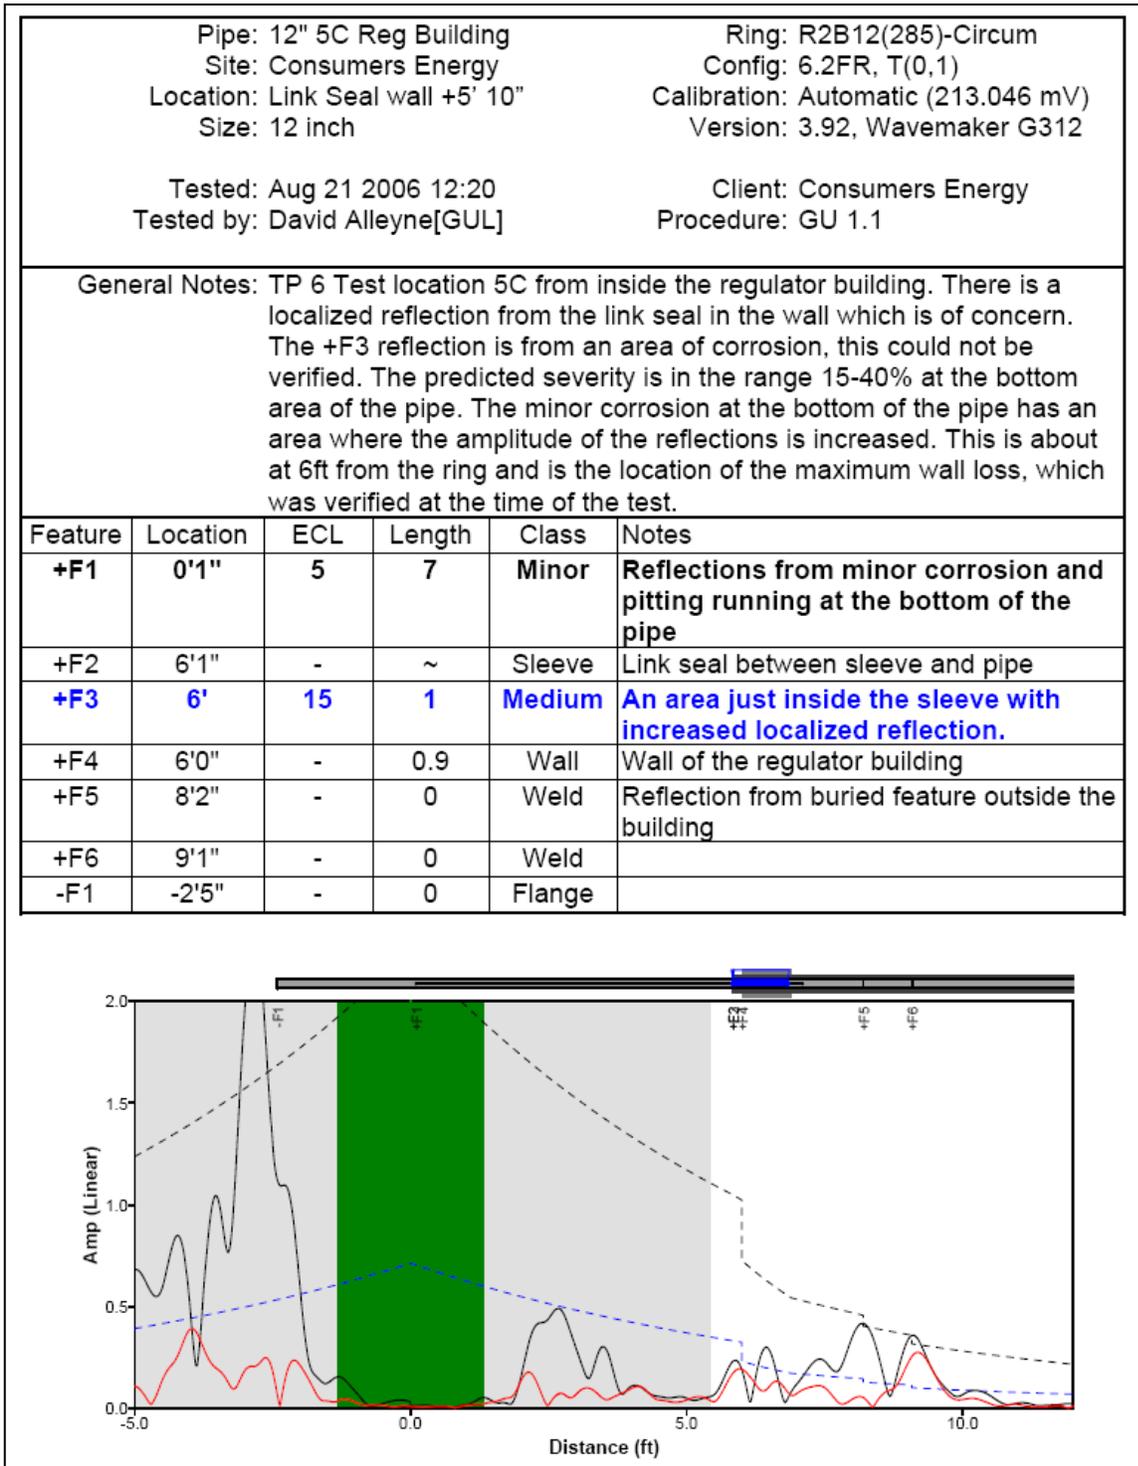
Figure 47. Dig Site 5C - PE.

Dig Site #5C - From inside the regulator building. There is a localized reflection from the link seal in the wall which is of concern but could not be verified. The predicted severity is in the range 15-40% at the bottom area of the pipe. The minor corrosion at the bottom of the pipe has an area where the amplitude of the reflections is increased about 6ft from the ring (right at the wall penetration downstream of #5C) and is the location of the maximum wall loss. The wall loss at the Link Seal area is predicted to be in the 20-40% range.

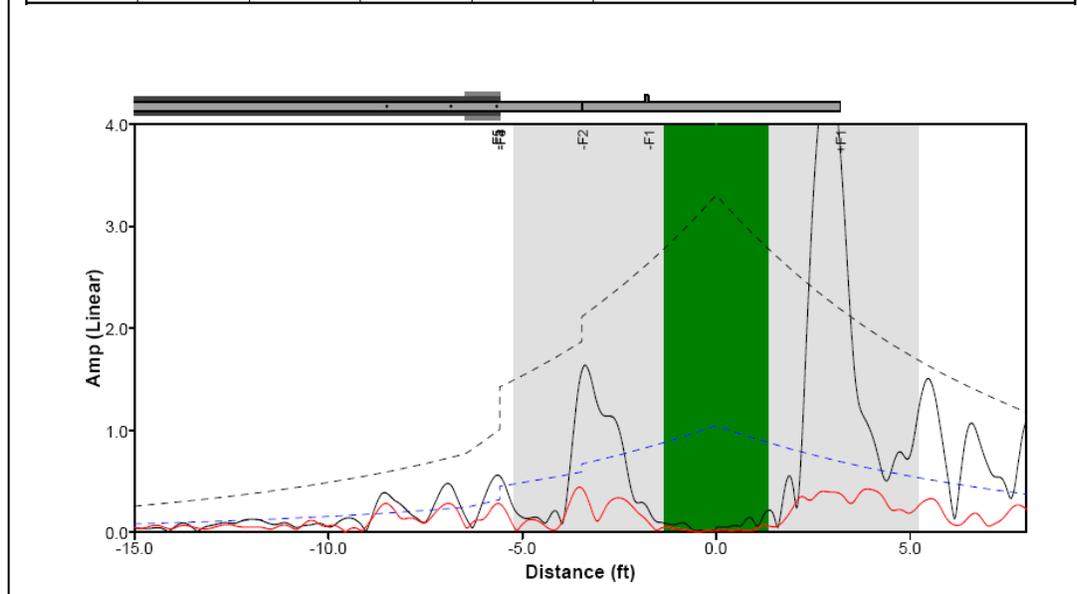
Figure 56. Dig Site 6A - PE.

Pipe: 12" 6A Reg Building Site: Consumers Energy Location: Link Seal inner wall -5ft Size: 12 inch (0.375 in)		Ring: R2B12(285)-Circum Config: 6.0FR, T(0,1) Calibration: Automatic (319.45 mV) Version: 3.92, Wavemaker G312			
Tested: Aug 21 2006 08:54 Tested by: David Alleyne[GUL]		Client: Consumers Energy Procedure: GU 1.1			
General Notes: TP 1 test location 6A in the Regulator building at the Red Run Regulator Station in Warren. There are reflections from the pipe at the seal location within the wall penetration area. These reflections are above the reportable call level but have been interpreted to be from the seal contact with the pipe. None of the reflections have been interpreted to be from corrosion above the call level.					
Feature	Location	ECL	Length	Class	Notes
+F1	3'2"	-	0	Flange	
-F1	-1'9"	-	0	Vent	Visible
-F2	-3'5"	-	0	Weld	
-F3	-5'7"	-	~	Sleeve	Link seal between seal and pipe. The reflections are from the tightness of the seal onto the pipe

-F4	-5'7"	-	0.9	Wall	The pipe is bitumen coated and buried after the wall
-F5	-5'8"	15	3	Cat 1 & 2	Reflections interpreted to be mainly caused by the link seal tightness and changes to the coating and buried conditions in this area.

Test location 6A in the Regulator building at the Red Run Regulator Station in Warren. There are reflections from the pipe at the seal location within the wall penetration area. These reflections are above the reportable call level but have been interpreted to be mainly from the seal contact with the pipe and changes to the coating and buried condition. None of the reflections have been interpreted to be from corrosion with wall loss greater than 30% depth.

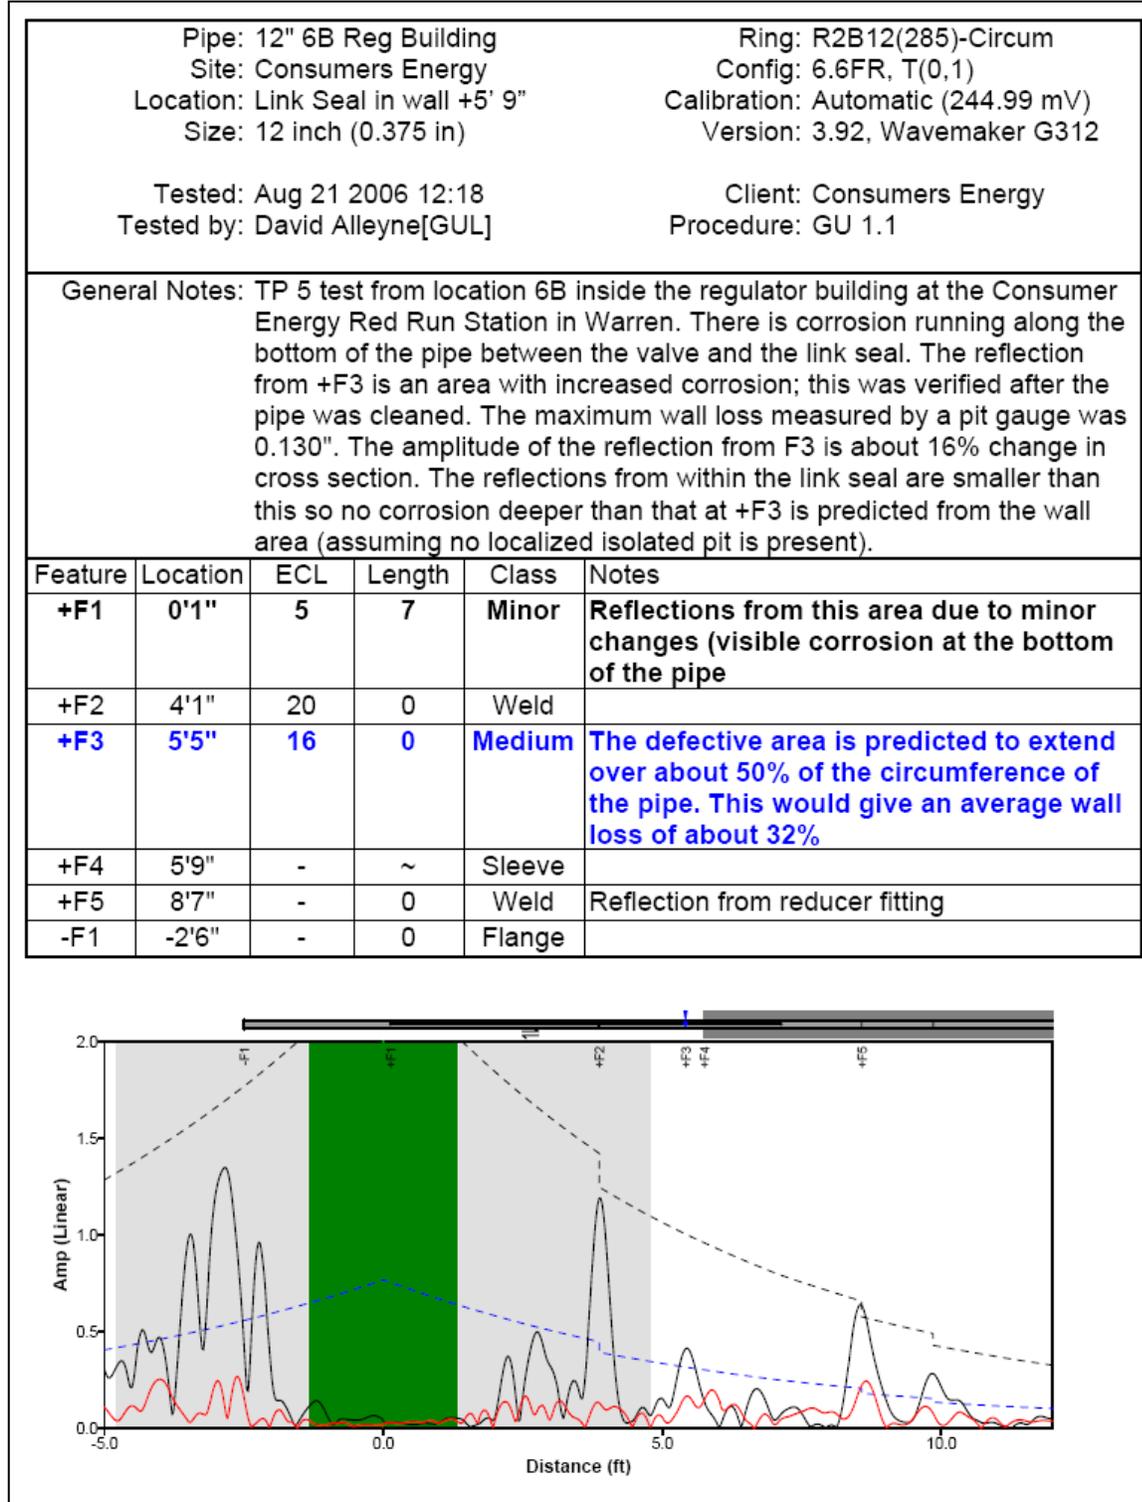
Figure 57. Dig Site 6B - PE.

TP 5 test from location 6B inside the regulator building at the Consumer Energy Red Run Station in Warren. There is corrosion running along the bottom of the pipe between the valve and the link seal and an area with increased corrosion; this was verified after the pipe was cleaned. The maximum wall loss measured by a pit gauge was 0.130". The amplitude of the reflection from F3 is about 16% change in cross section. The reflections from within the link seal are smaller than this so no corrosion deeper than that at +F3 is predicted from the wall area (assuming no localized isolated pit is present).

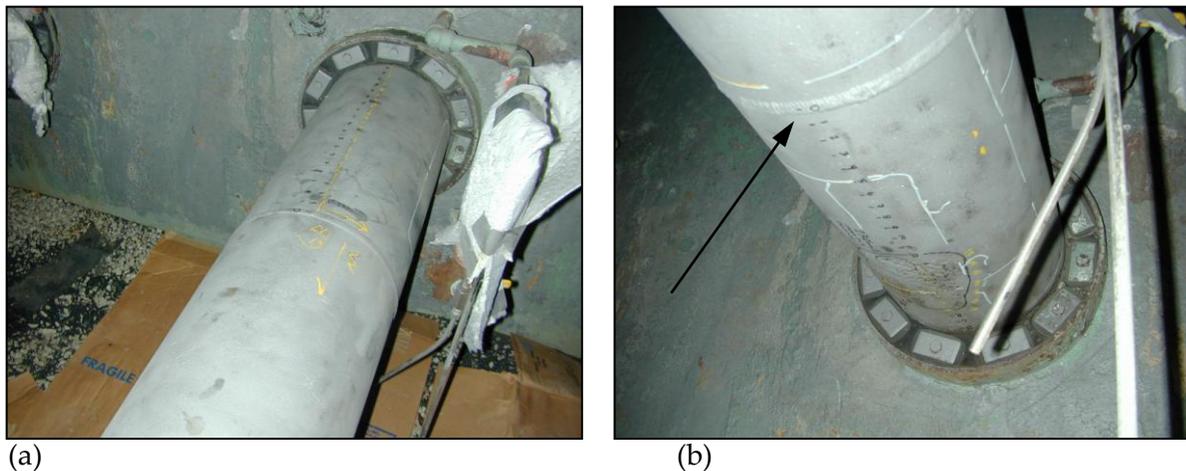
**Figure 59. Radiography of Site 6B.**

Outer diameter corrosion was verified visually on the bottom as marked with black marker as seen in (b). The Lo position for radiographic images was on the girthweld at the 06:00 position (yellow arrow). Radiographs of the pipe to determine presence and extent of ID corrosion were inconclusive. No other RT inspections were performed on this pipe. Both (a) and (b) views are looking east.
